Most Common Causes for Preventable Premature Commutator Failure

AKARD COMMUTATOR OF TENNESSEE

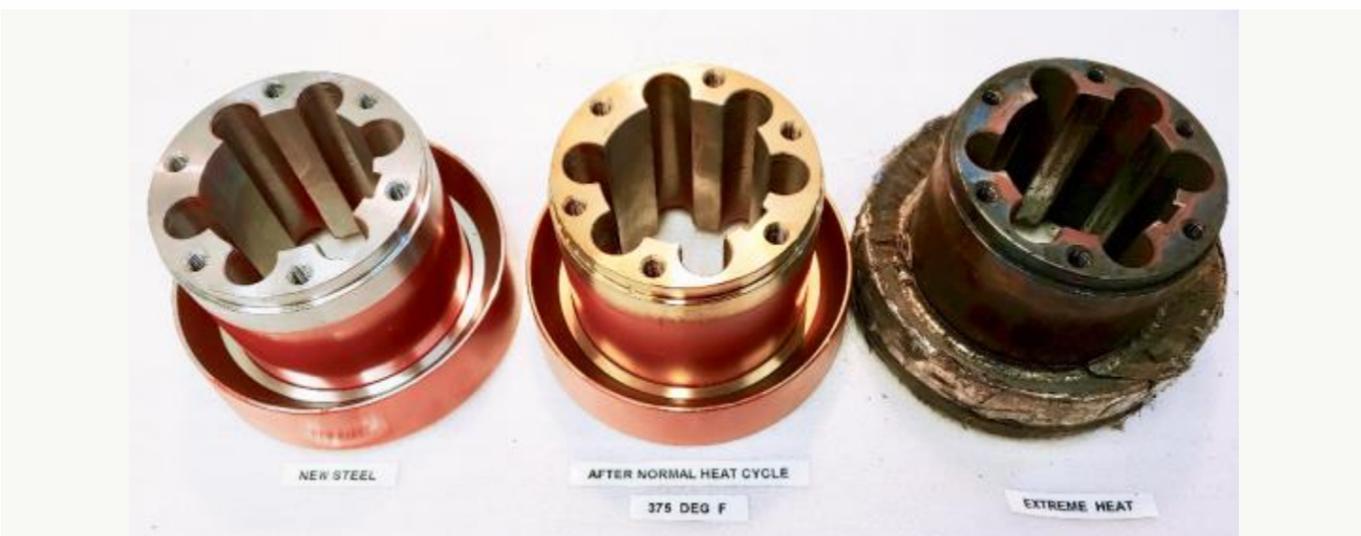
Pictured above: A steel part from a commutator that failed prematurely having clear signs of severe overheating resulting from a torch being used to expedite the installation process onto the armature shaft as evidenced by the uneven heating originating in bore on riser end in addition to a brand new steel part prior to normal oven cycles and a brand new steel part after completing multiple cycles of normal heating to 190°C/375°F. Please note, the overheated commutator in these images has not been in a burn-off oven. Using an oven for preheating might take longer, but it's vastly superior than risking premature commutator failure as a result of overheating.

One often overlooked way to prevent overheating is to utilize an oven with maximum temperature set at 190°C/375°F to preheat commutators for installation on the armature shaft. Using a torch to preheat any type of commutator is extremely risky due to the maximum temperature rating of most electrical insulation materials to ground (more details to follow) and the fact that there's no good way to evenly heat the steel part without risking severe damage internally from overheating.

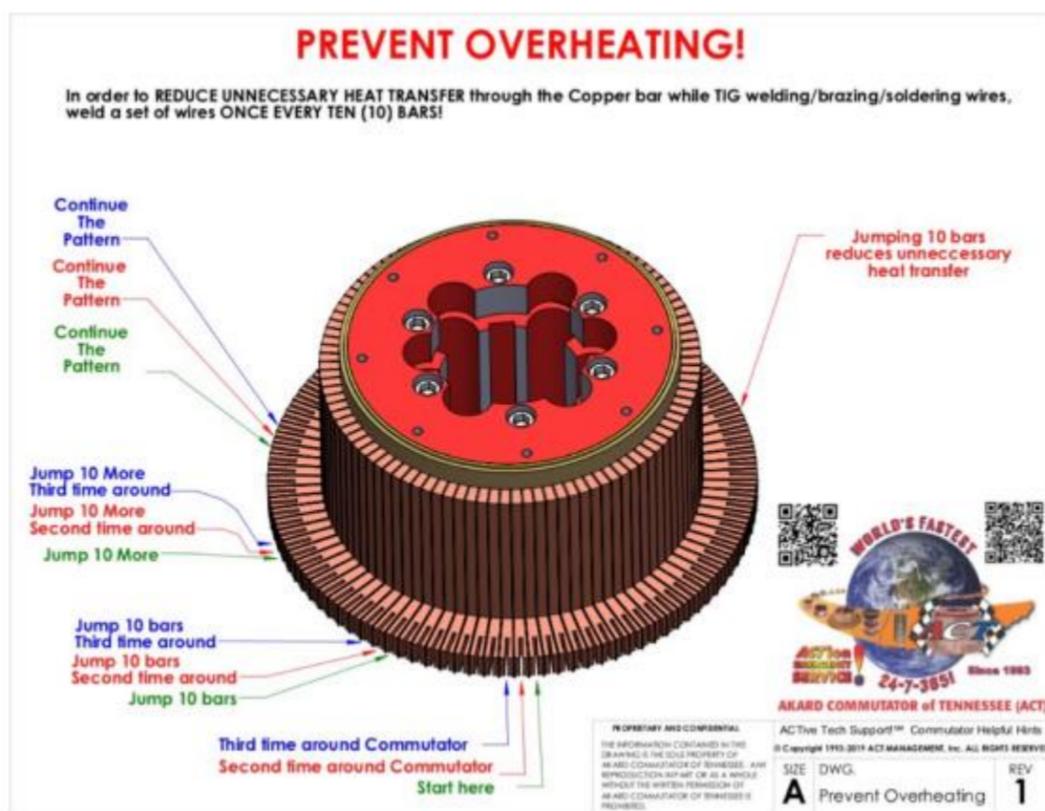
There are obvious reasons like burning the segment mica between the bars and melting the copper risers themselves, but there are also concerns that might not be so readily recognized.

The Electrical Apparatus Service Association (EASA) recommends skipping at least ten bars after TIG welding coils into slots of solid riser commutators rather than permitting heat to build up by welding (or even brazing or soldering) connections on bars that are side-by-side or closer together than every tenth bar.

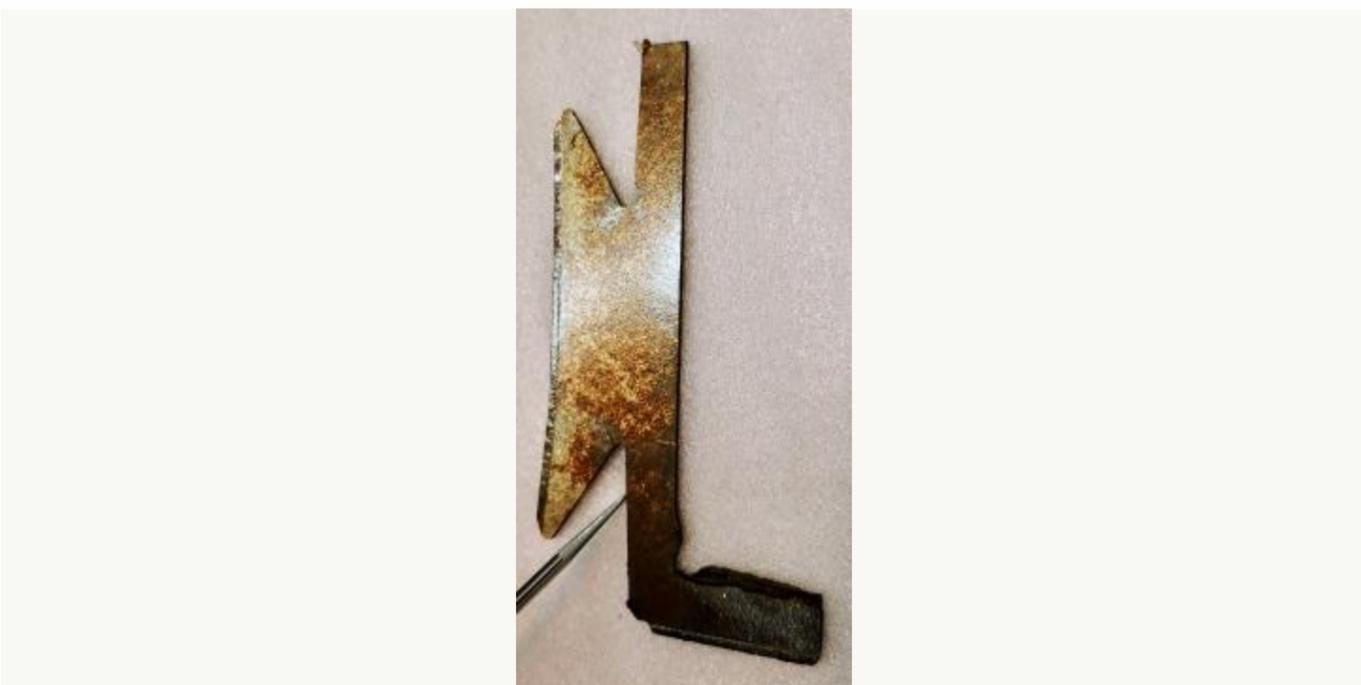
burned mica segment

Even when mica segments might return to original position along with the copper bars when the overheated commutator cools down, mica segments that were cracked at or near the apex of the internal dovetail are extremely likely to lift once placed in service as a result of their mechanical strength integrity being compromised from the swelling of the copper segments forcing them to fracture. This sort of unrecognized internal damage is the root cause of the vast majority of "lifting mica" type premature commutator failures and it can be easily prevented by taking

additional precaution skip ten bars to prevent overheating when TIG welding, brazing, or soldering connections during the winding process.

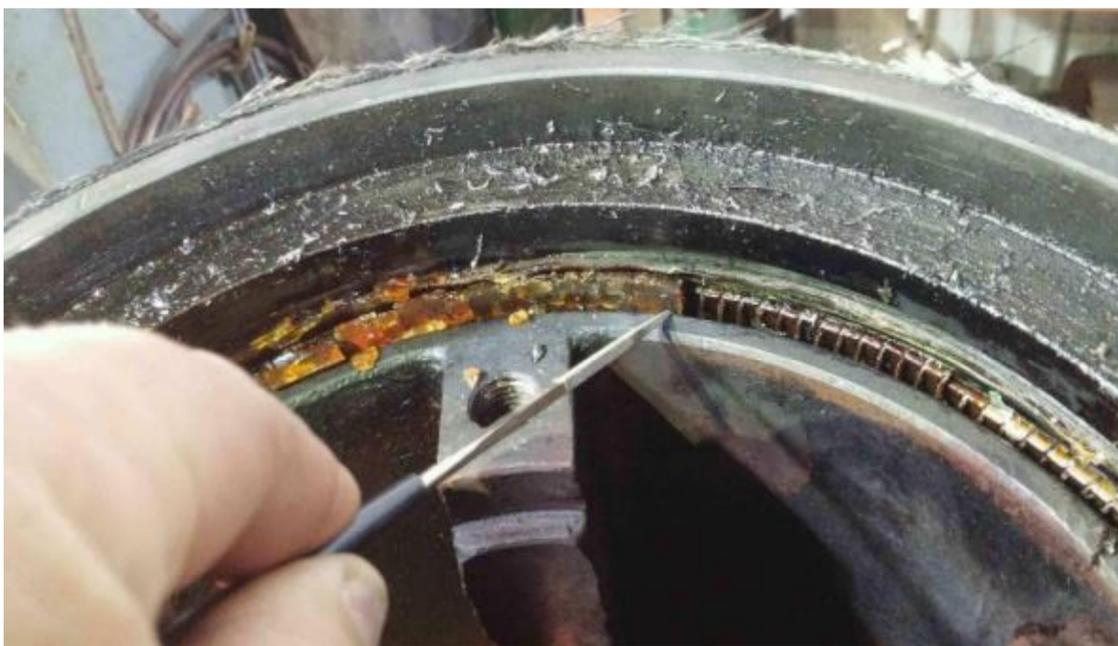
Premature commutator failure due to being VPI/dipped during winding process. EASA has had Seminars and been publicizing that v-ring type commutators should never be submerged in resin (dipped) for many years, but some folks still might not realize that commutator copper should also never come into contact with any resin at any time while vacuum is being applied during VPI process. Quite a few folks have been lowering the wound armature into the resin to a point just touching the commutators' risers, thinking that since the entire commutator was not submerged everything would be alright. This practice, in and of itself, is not likely to cause problems with the commutator if no vacuum is applied to the unit while the resin remains uncured. However, whenever vacuum is applied, it is extremely important to be certain that the copper bars of the commutator are not touching the resin as the vacuum will pull some of the resin inside the commutator. This will result in greatly increased likelihood of premature failure of the commutator, even though it was never "submerged" in resin.

A little extra care to prevent exposure to resin can mean the difference in years of commutator life expectancy. Please take note.
